WHITE'S POND DAM

NH 00106

PHASE I INSPECTION REPORT
NATIONAL DAM INSPECTION PROGRAM

AUGUST 1978

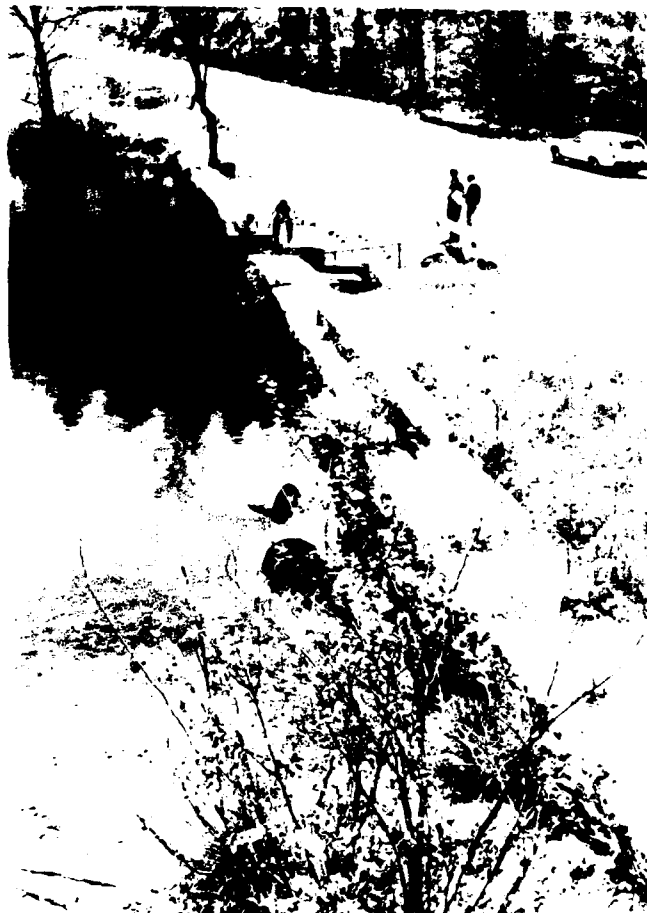
Overview from right abutment

The double courses of granite, with capstone, which form the dam proper were somewhat unequal in alignment, consistent with early construction techniques (Fig. 3 and Overview Photos). However, displacement pond-ward is evident probably caused by former trees, since removed. One tree, a probable contributor to the movement, still remains. Since the outlet of the dam is located opposite the sag point of Rt. 107 with no controlled drainage, storm runoffs flow towards the flume section and the outlet headwall. This condition has caused surface scour adjacent to the flume walls (Photo 1) and undermining and loss of ground at the northeast wing wall.

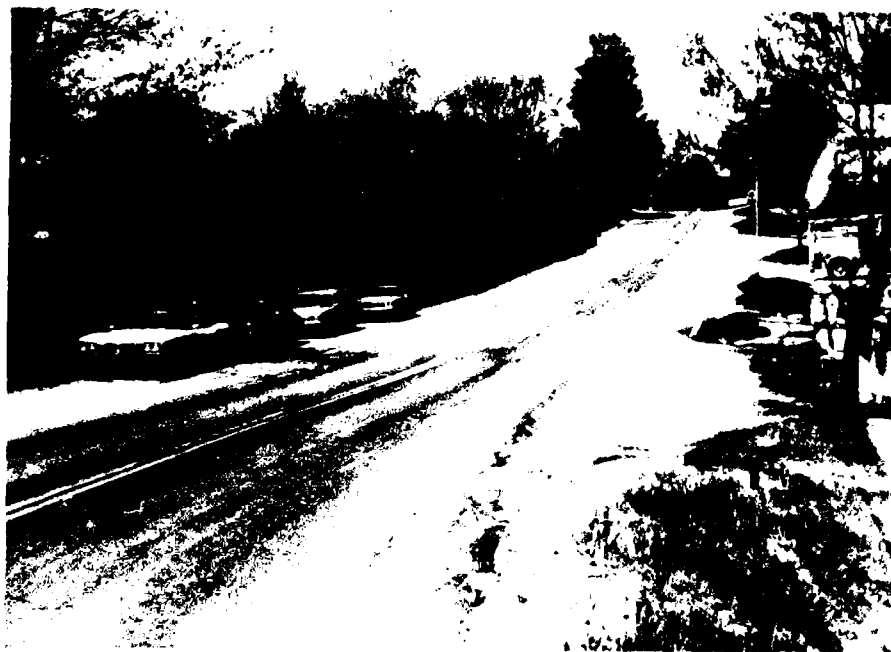
Overview from left abutment
